**RESPONSE OF  
NSTAR GAS COMPANY  
TO THE NOTICE OF PROBABLE  
VIOLATION  
ISSUED BY THE DEPARTMENT  
OF TELECOMMUNICATIONS**

On July 24, 2002, an incident involving a release of natural gas occurred at 65 Main Street, Hopkinton. This incident resulted in two fatalities, injuries to other persons and significant property damage. The Pipeline Engineering and Safety Division ("Division") of the Department of Telecommunications and Energy ("Department") investigated the incident as required by G.L. c. 164, § 105A and a Federal Certification Agreement as provided by 49 U.S.C. § 60105.

**Analysis of Jurisdictional Gas Piping and  
Appurtenances Removed From 65 Main Street,  
Hopkinton, Massachusetts**

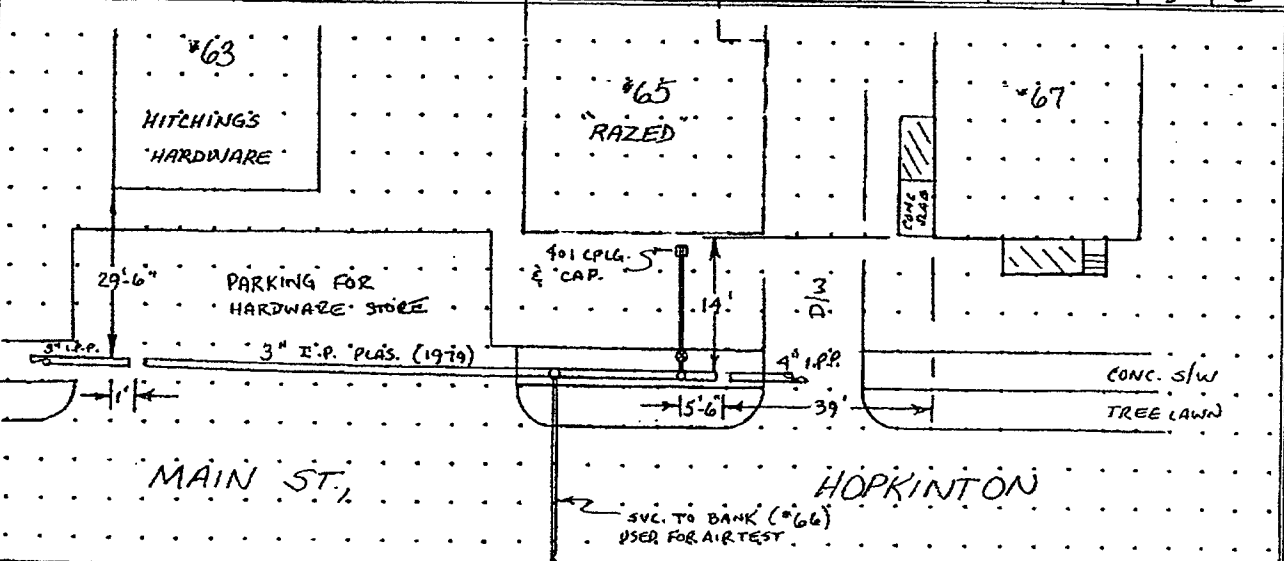
REMARKS: CREW CALLED IN AND RESPONDED TO INCIDENT AT #65 MAIN ST., HOPKINTON. COULD NOT ACCESS TAP LOCATION OR CURB COCK DUE TO POSITION OF HOUSE. CREW EXCAVATED TWO (2) HOLES AND SQUARED OFF AND ISOLATED MAIN & SERVICE TO #65. CREW EXCAVATED AND CUT AND CAPPED EXISTING 1/2" I.P.P. INSERT JUST OUTSIDE OF FOUNDATION WALL. CREW ALSO CUT AND CAPPED AFTERNO RECAUT OF MAIN IN FRONT OF #65. APPLIED AIR TEST & SWAP TESTED ALL FITTINGS. AIR TEST - O.K. - PLATED MAIN HOLES AND BACKFILLED SERVICE HOLE. NOTE: 580PSI AIR TEST REQUESTED BY D.T.E.

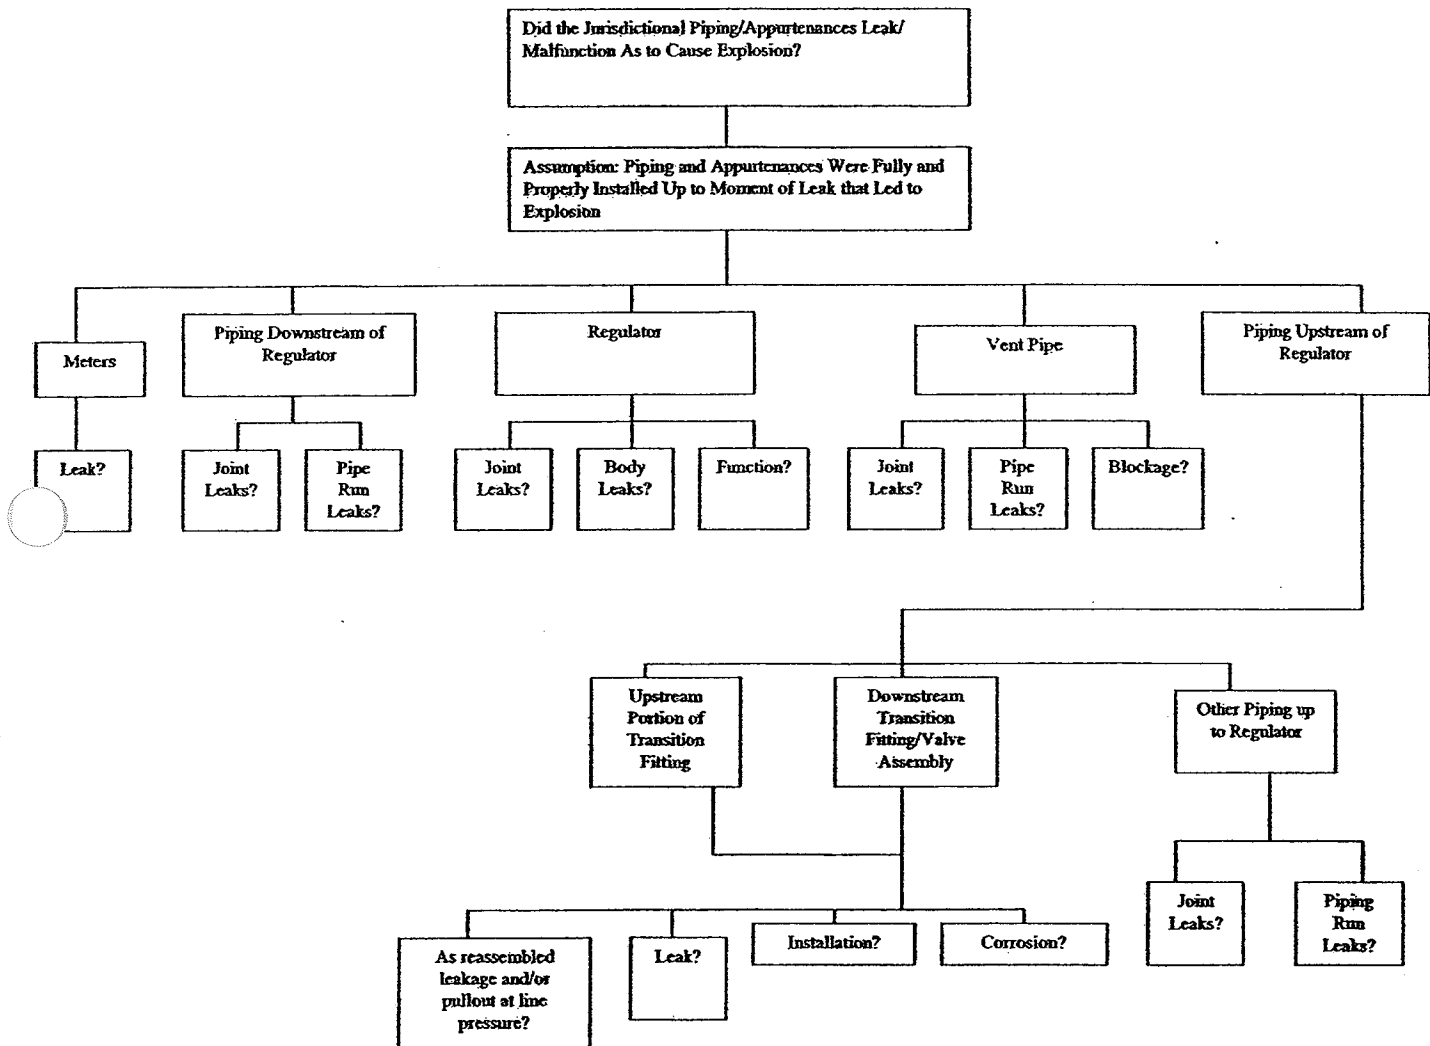
A common method of organizing a large investigation such as this is the construction of a fault tree to aid and guide the analysis, to help develop investigative protocols, and to define the reasonably probable failures that could occur in a system. The fault tree used to develop the test and evaluation protocol is illustrated below.

“Reasonably probable” is a term used during the construction of a fault tree to distinguish between fanciful failure explanations and those that could actually occur.
